Impact Testing on Reinforced Carbon-Carbon Flat Panels With BX-265 and PDL-1034 External Tank Foam for the Space Shuttle Return to Flight Program

*Matthew E. Melis, Duane M. Revilock, and Michael J. Pereira
Glenn Research Center, Cleveland, Ohio*

*Karen H. Lyle
Langley Research Center, Hampton, Virginia*

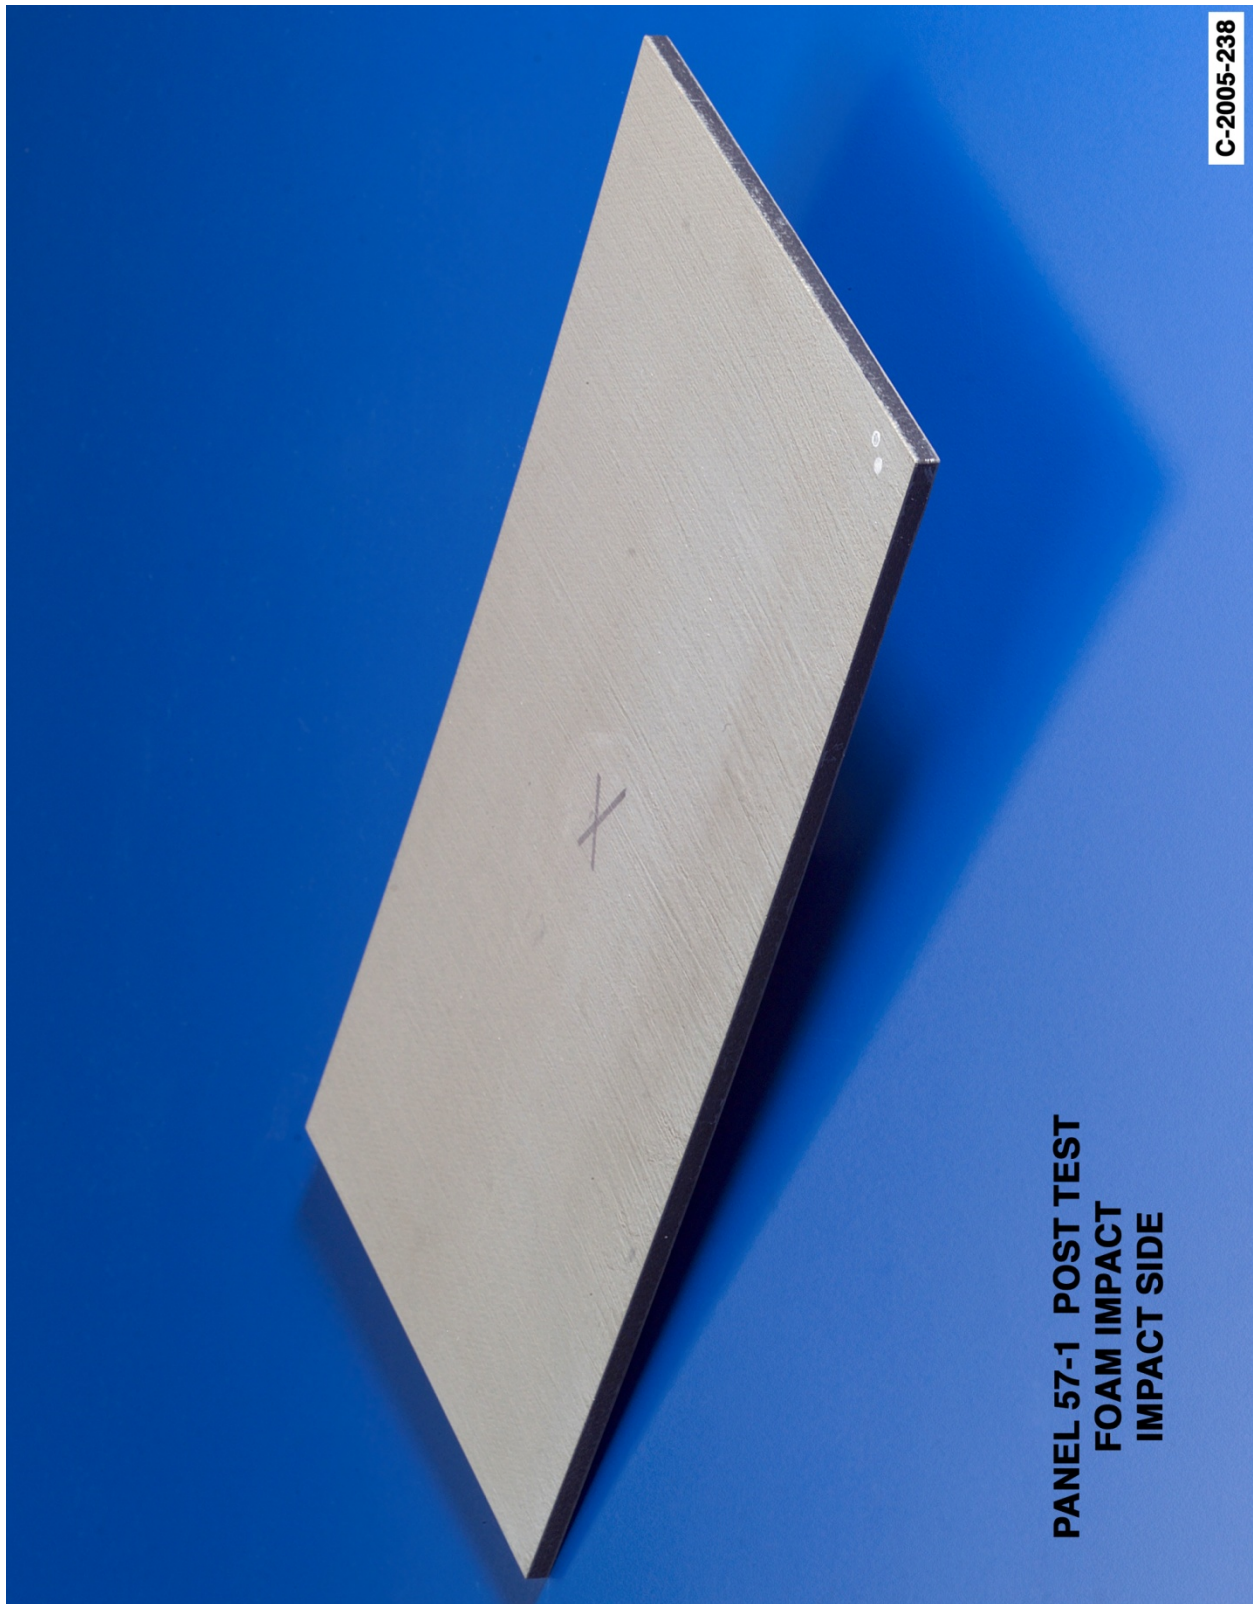
Figure D9-2.—Digital photography front (impact side) face of panel 57-1 at 1970 to 2000 ft/s with a BX-265 foam cylinder (nominally 1.5 in. in diameter by 3 in.) at a 45° impact angle. Test GRCC 178.

4. In test GRCC 178, the foam projectile broke into two pieces which were tracked at 1970 and 2000 ft/s respectively at impact on RCC panel 57-1. No visible or NDE damage was detected due to this test.

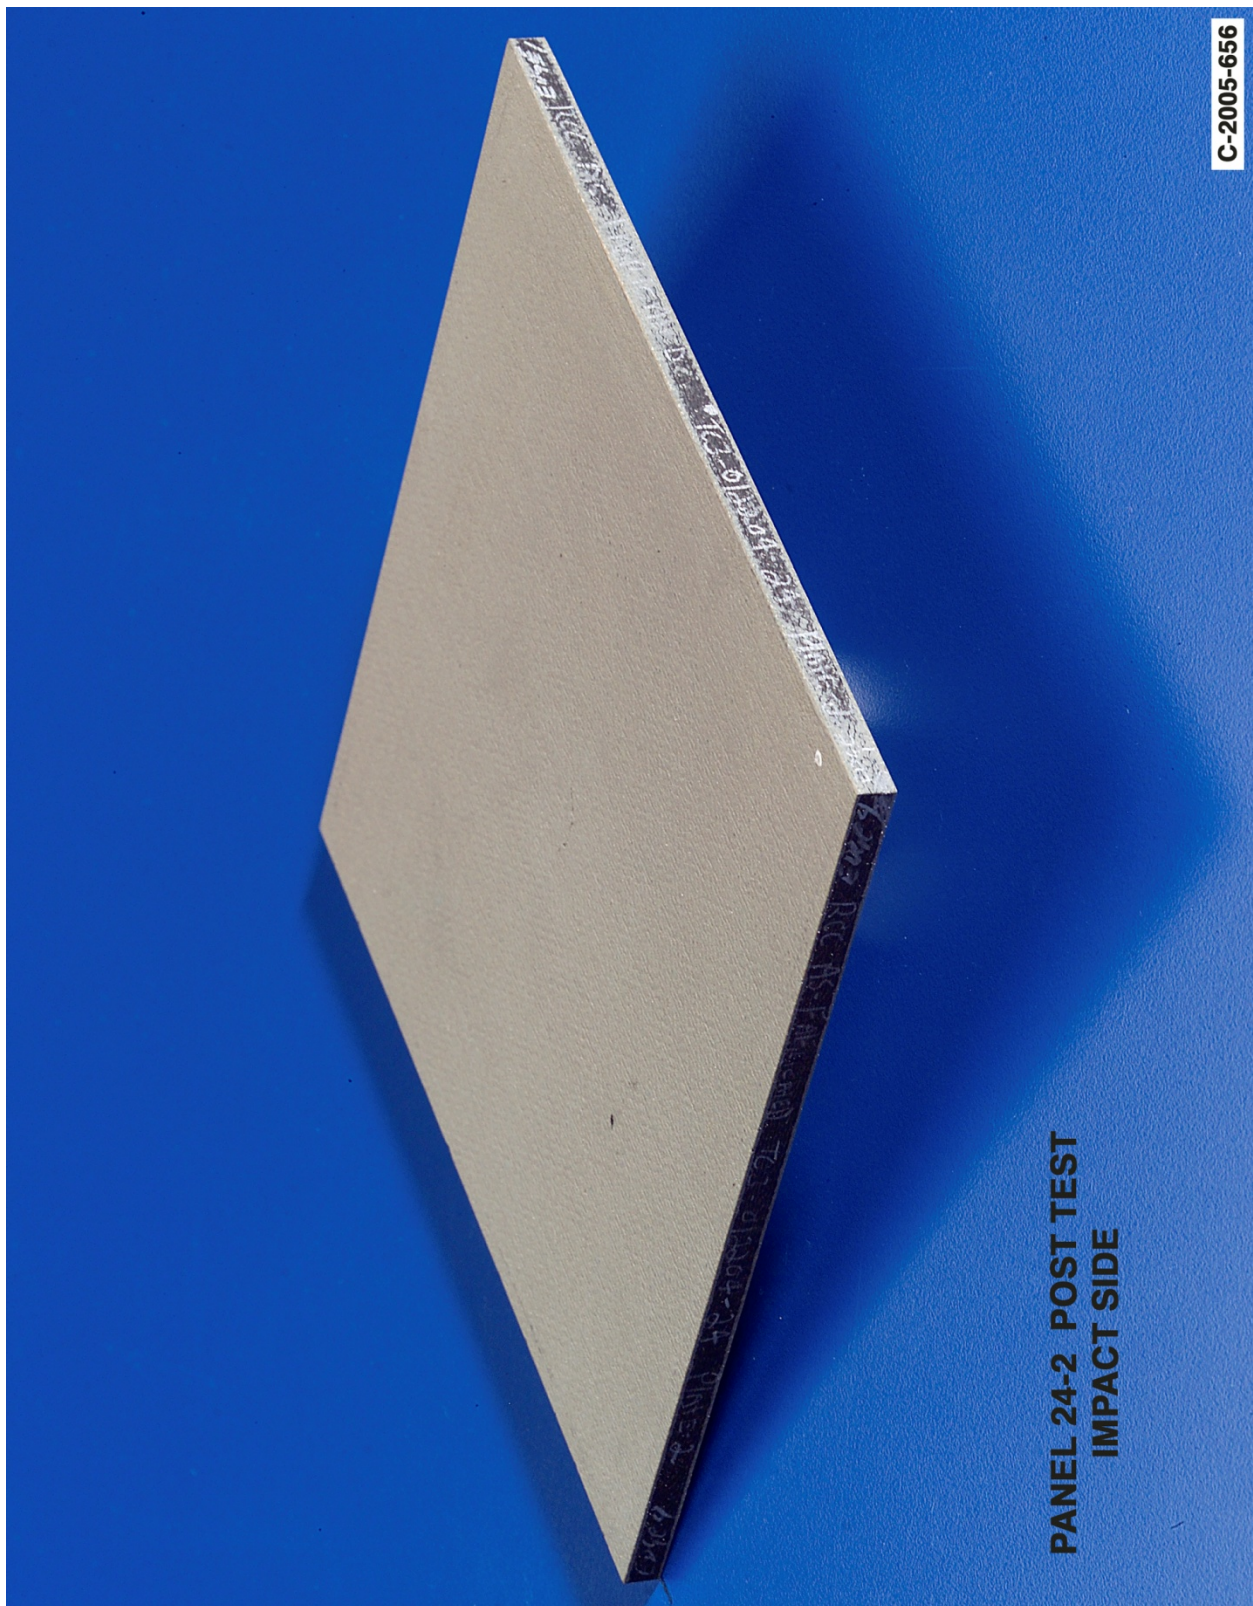
Figure E12-2.—Digital photography front (impact side) face of panel 24-2 at 1825 ft/s with a PDL foam cylinder (nominally 1.5 in. in diameter by 3 in.) at a 90° impact angle. Test GRCC 203.
